Inspection Report

Mr. Sample Report

Property Address:
Practice Street
Anytown IL 60003

Date: 10/20/2012	Time: 08:00 AM	Report ID: Sample
Property: Practice Street Anytown IL 60003	Customer: Mr. Sample Report	Real Estate Professional:

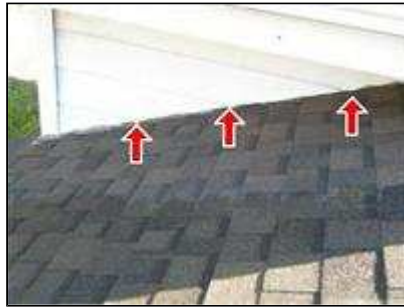
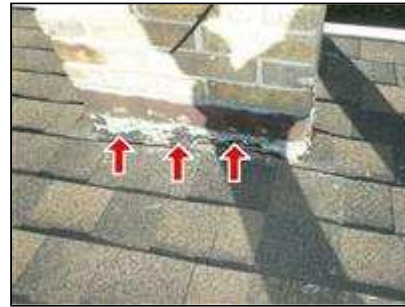
1.1 Picture 1 Sloppy Workmanship

1.1 Picture 2 Sloppy Workmanship

The metal step flashing at the sidewalls of the 2nd floor and on the chimney were not installed very neatly, this is an indication of sloppy workmanship. There is the potential that these areas may start leaking within the next 5-10 years.

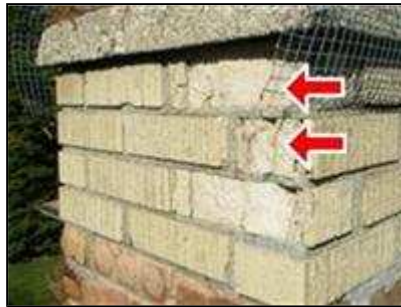
1.2 Picture 1 Spalling Briick

(1) There appears to be some spalling on the brick chimney surface, top 2-4 courses. If the underlying cause is not addressed, the deterioration can continue, leading to increased repair costs. You should have a masonry specialist or licensed chimney sweep evaluate this condition and make corrections if needed. This condition can sometimes be caused by excess moisture or condensation from the interior of the chimney or from cracks in the chimney crown. See Article 1B.02 for more information.

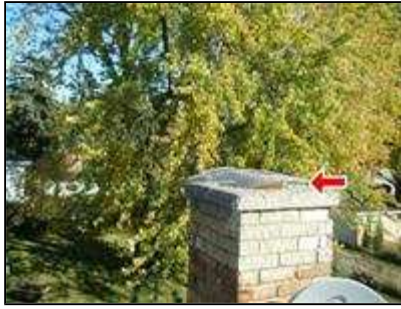
1.2 Picture 2 Screen on Chimney
Flue

(2) There is no chimney cap on the terra cotta flue, however, the flue is covered with a screen. Lack of a cap will allow water to enter the chimney. I recommend the unsightly screen be removed and a cap be installed by a qualified contractor before winter.

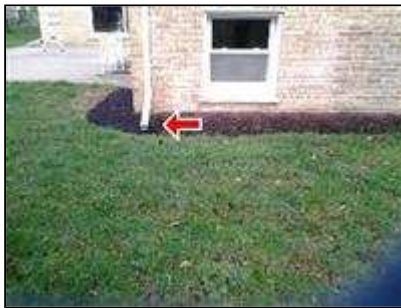
1.3 Picture 1

Some of the downspouts empty too close to the building. This will cause erosion or excess moisture to enter the foundation. I recommend they be extended to a minimum of 3 feet from the foundation. See article 36.06 for additional information.

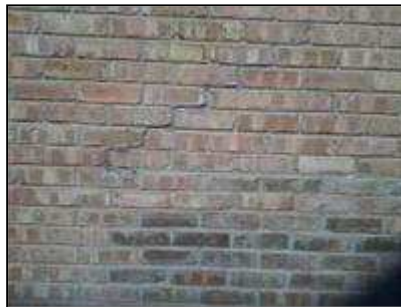
2.1 Picture 1 Masonry Repairs

There appear to have been some masonry repairs to the back of the home, I recommend you ask the seller why they were made and if there is a warranty associated with the repairs.

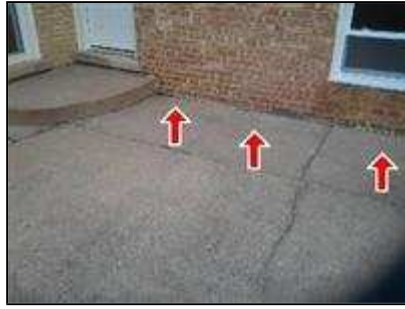
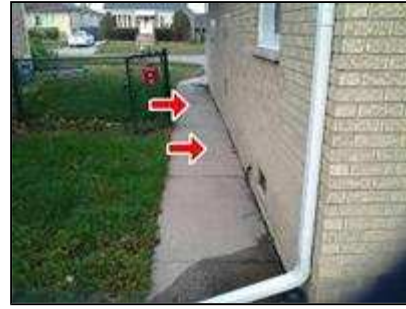
2.4 Picture 1 Settled Patio

2.4 Picture 2 Settled Sidewalk

(1) The concrete patio is cracked and settled slightly toward the home. This could cause moisture to seep down and through the foundation over time. I recommend further evaluation of the patio by a concrete contractor to determine the cost of repair or replacement of the concrete. Also, the sidewalk along the garage has also settled toward the foundation slightly. Mudjacking may be an option as well. See Article 1C.55 for more information.

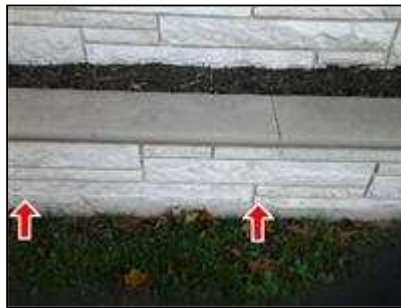
2.5 Picture 1

(1) I recommend you drill some weep holes between some of the mortar joints in the planter on the front of the home, this will allow the water to weep out the front of the planter instead of leaking to the interior.

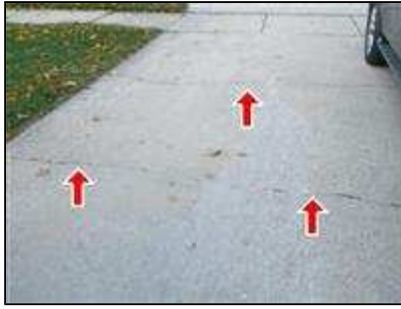
2.5 Picture 2 Cracks in Driveway

(2) There are typical settlement cracks in the concrete driveway. Over time, these cracks could become tripping hazards. I recommend you monitor these cracks, future repairs may be necessary. See Article 1C.24 and 2C.06 for more information.

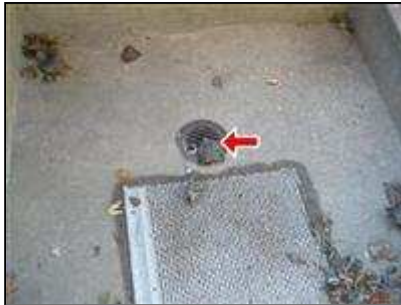
2.5 Picture 3 Areaway Drain

(3) The retaining walls from the basement areaway appear to be poured concrete. These areas are susceptible to flooding if the areaway drain gets clogged with leaves. You should keep this area clean of leaves and debris at all times. I also recommend you remove the small section of carpet that could clog the drain.

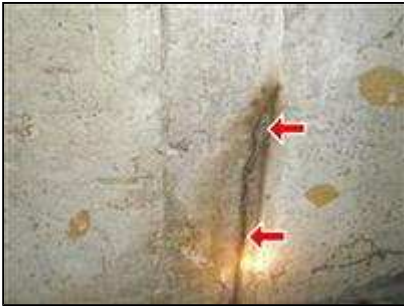
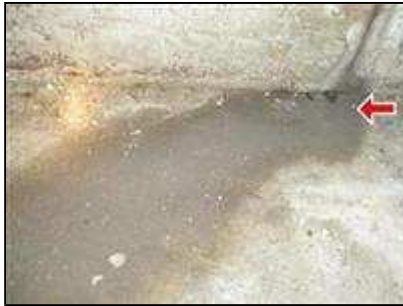
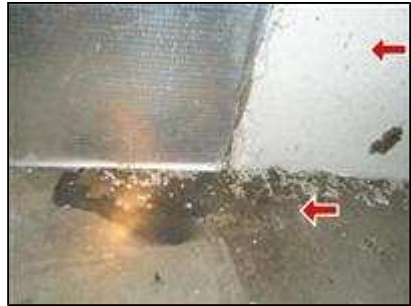
(1) There are at least 2 settlement cracks visible on the on the interior foundation walls in the crawlspace. There appears to be signs of active seepage at these cracks. I recommend repair by a qualified crack repair company. See article 1C.21 for additional information.

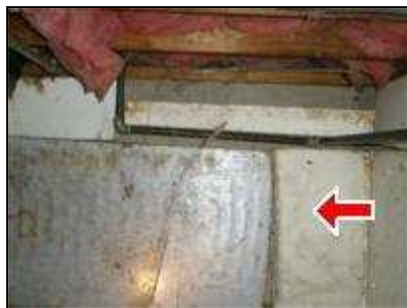
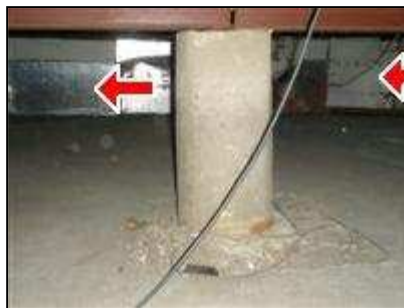
3.0 Picture 4 Insulation

3.0 Picture 5 Insulation

(2) Visual inspection of the foundation walls in the basement and crawlspace was restricted by insulated walls in the crawl and finished walls in the basement. You should monitor the baseboards closely during heavy rain storms.

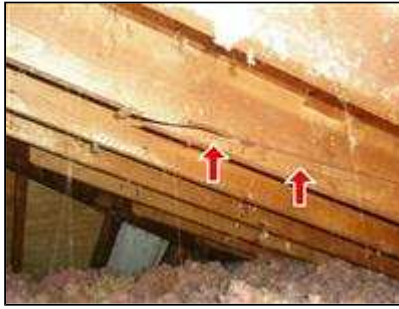
**3.1 Picture 1 Cracked Rafter**

There is a cracked rafter in the attic above the bedrooms. This could possibly cause an area of the roof to sag under heavy snow loads. I recommend further evaluation and repair by a qualified contractor before the close of escrow.

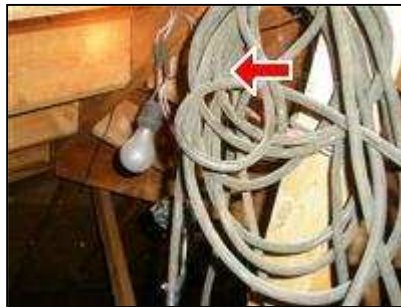
4.2 Picture 1 Unsafe Extension Cord

There is an unsafe extension cord with light sockets attached. It was plugged into the light fixture. I did unplug the cord but it should be thrown away before someone tries to use it.

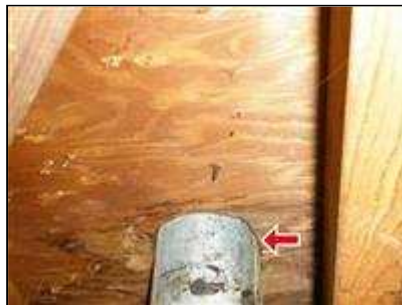
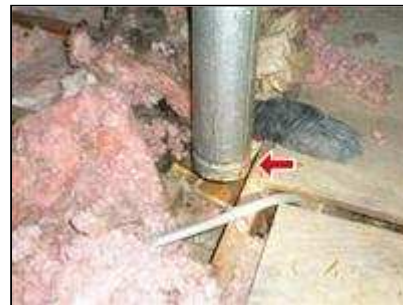
4.3 Picture 1 No Clearance

4.3 Picture 2 Abandon Flue Pipe

(1) There is flue pipe going through the garage roof that has been abandon. There is an issue with clearance to combustibles should you install a new gas heater and start using it. "B Vent" flue piping needs a minimum of 1 inch clearance to combustibles.

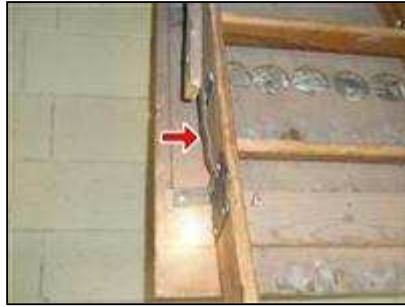
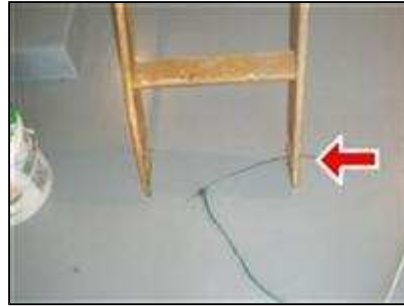
(2) The pull down ladder in the garage does not operate properly and is somewhat unstable, this is a safety concern. I recommend repair or replacement by a qualified contractor.

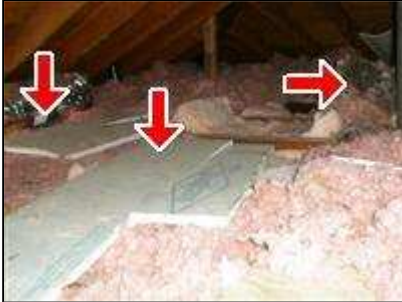
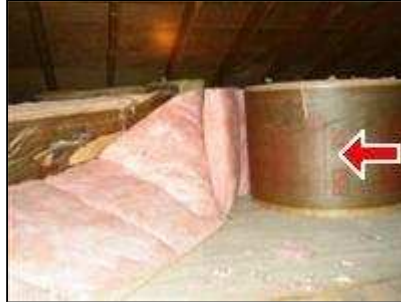
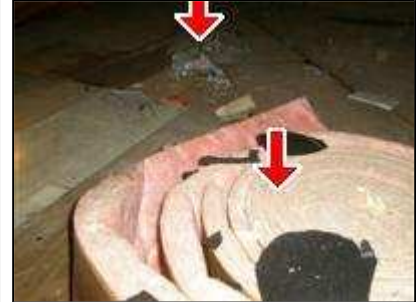
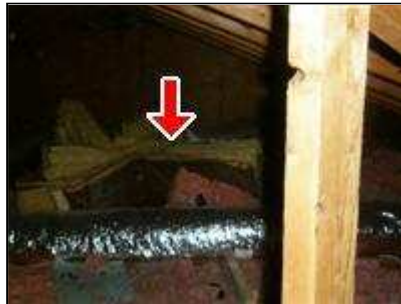
4.3 Picture 5 Debris

4.3 Picture 6 Insulation

4.3 Picture 7 Insulation and Debris

4.3 Picture 8 Insulation

(3) There is some debris and some rolls of insulation in the garage attic, the insulation can be used to improve the space conditioning, however, the Kraft Paper side of the insulation should be removed or split if it is placed over existing insulation as it is considered a vapor barrier. See Article 1C.03 and 9D for addition information.

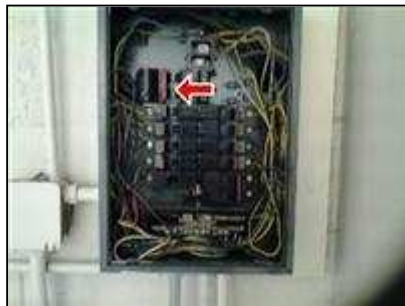
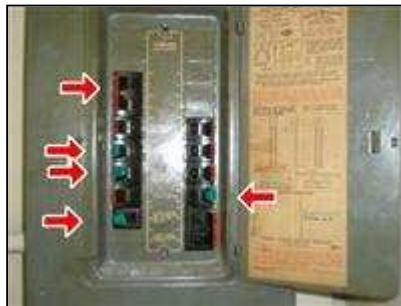
5.1 Picture 1 Main Disconnect

5.1 Picture 2 Main Disconnect and Double Tap Locations

(2) There is no room for additional circuits in the main distribution panel. If you plan to add new circuits, a larger or additional panel will be needed. I recommend further evaluation by a licensed electrician.

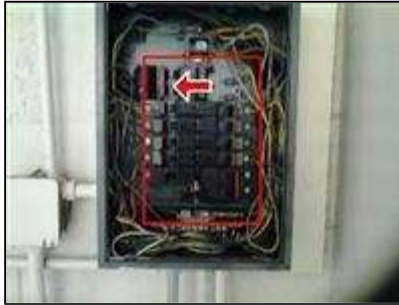
5.2 Picture 1 Federal Pacific/Stab-Loc Panel

(1) This is a Federal Pacific "Stab-Lok" brand panel. These panels have proven to be unreliable. The breakers can fail to operate when needed and can overheat at the connection between the circuit breaker and the bus bar, leading to an electrical fire. You should have this panel evaluated by a qualified electrician. See Articles 5A.00, 5A.01 and 5C.67 for more information. Also, the following Internet link will give you a better understanding of the FPE issues. <http://www.inspect-ny.com/fpe/fpeid.htm>

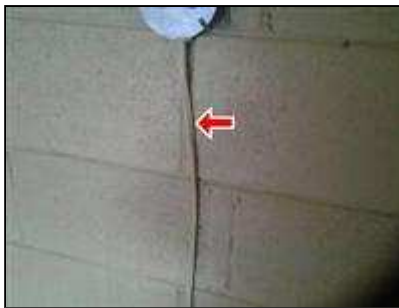
5.2 Picture 2 Romex Wiring to Light

(2) There is underground Romex wiring in the garage that runs to the pole light on the back of the patio. This wiring is not approved for use in most of the Chicagoland area. I recommend further evaluation by a licensed electrician or local code official. See Article 5A.11 for additional information.

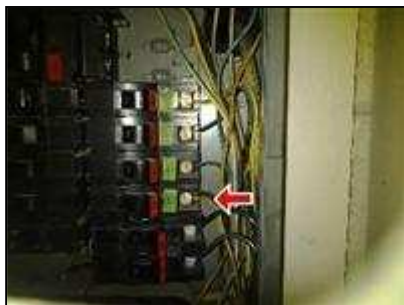
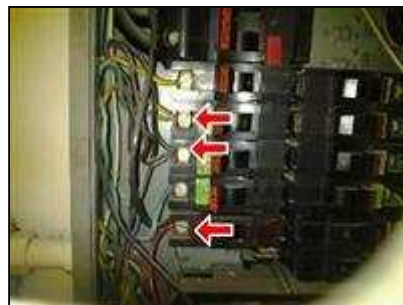
5.2 Picture 3 Double Taps

5.2 Picture 4 Double Taps

(3) There are 4 breakers in the panel with double taps. Most terminals are not designed to accommodate more than one wire. This may result in a poor connection or unsafe connection. I recommend further evaluation by a local code official and repair by a licensed electrician. See Article 5C.72 for more information.

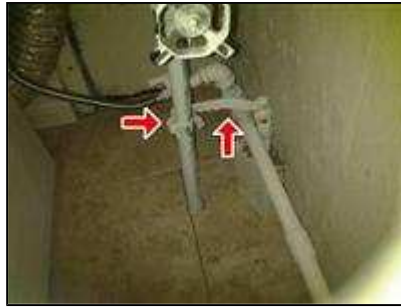
5.3 Picture 1 Ground Bonding Strap and Clamp

The main service is grounded to the plumbing on the street side of the water meter. You should check the ground bonding strap periodically to ensure it is clamped tightly around the water line. See Article 5A.05 for more information.

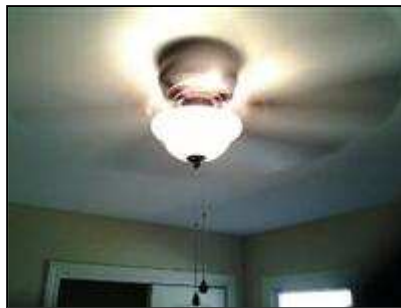
5.4 Picture 1 Noisy Ceiling Fan

The ceiling fan in the master bedroom is very noisy, since it is a new fixture, it should be repaired or replaced.

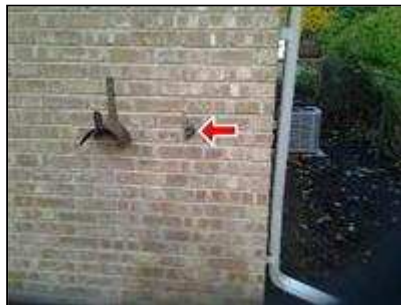
6.0 Picture 2 Standard Hosebibb

(2) I was unable to identify the location of the interior shut-off valve for the conventional hose bibb on the back of the home. A shut-off is needed to prevent freezing in winter. **I recommend you ask the seller where it is located** or have a licensed plumber install a frostproof hosebibb which would eliminate the need for a shutoff valve, this will most likely require the removal and replacement of drywall If a valve is not located, then the pipe is freeze vulnerable in the winter. See Article 4A.00 for more information.

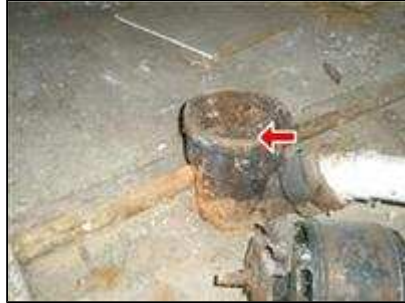
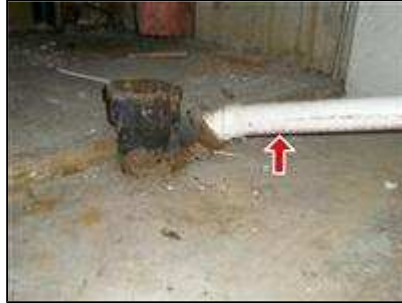
6.3 Picture 1 Open Line or Missing Vent Connection

6.3 Picture 2 Drain Line from Kitchen Sink

There is an open drain line in the crawlspace near the sump pump. The uncovered line could allow sewer gas to enter the crawlspace, It most likely needs to be attached to a vent pipe. Drain water from the kitchen sink and disposer drain into this connection. I recommend further evaluation by a local code official and repair by a qualified plumber.

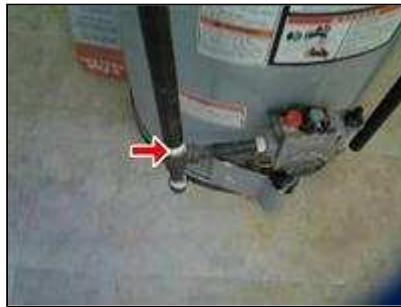
6.4 Picture 1 Gas Leak on Water Heater Connection

(1) There is a gas leak at the gas shutoff valve for the water heater. This is a safety concern. I recommend further evaluation and repair by the gas company or a qualified plumber. See article 4C.28 for additional information

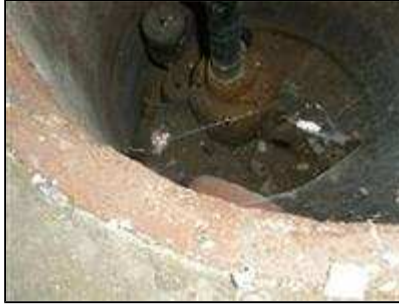
6.5 Picture 1 Dry Sump Pump

(1) There is a sump pump in the crawlspace. This is a device designed to pick up and discharge water from a low point in the building such as a dug out pit called a sump. The sump pit was dry at the time of the inspection. The pump was unplugged, however, I did plug it in and operated the the float switch. See Articles 1C.17 and 1D for more information.

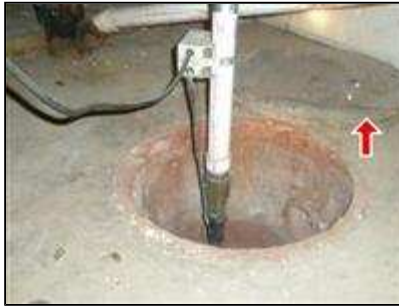
6.5 Picture 2 Cover Needs to be Installed

(2) The cover is missing on the sump pump. This is a safety concern with small children. Recommend a cover be installed to prevent small children and materials from accidentally getting into the pit.

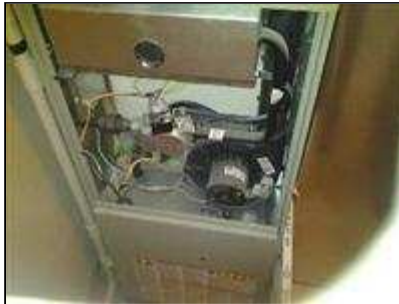
7.1 Picture 1 Dust Covered
Furnace

The interior of the furnace is covered with construction dust. I recommend the furnace be inspected and serviced in the fall by a qualified HVAC contractor. See article 6A.05 for additional information.

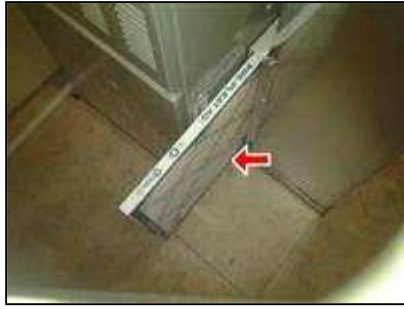
7.3 Picture 1 Dusty Filter

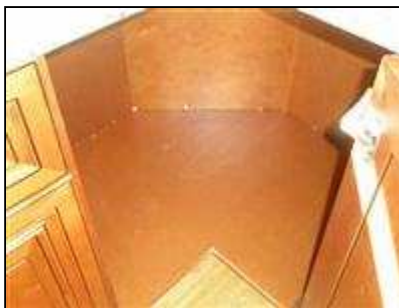
8.6 Picture 1 No Rotating Shelves

The corner cabinet in the kitchen is missing a "Lazy Susan" or rotating shelves. These are typically included with corner base cabinets. I recommend you check with the seller or the cabinet manufacturer about installing them.

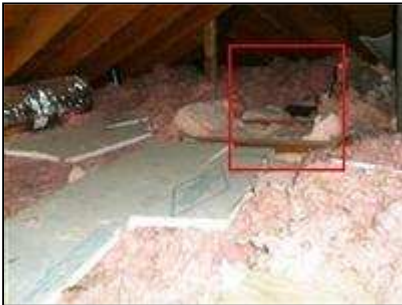
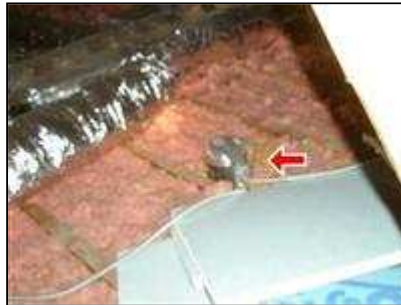
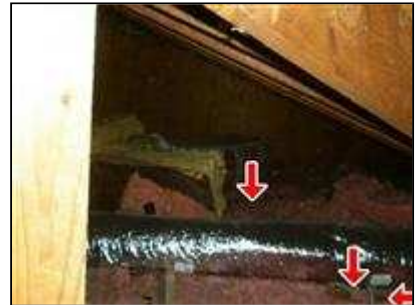
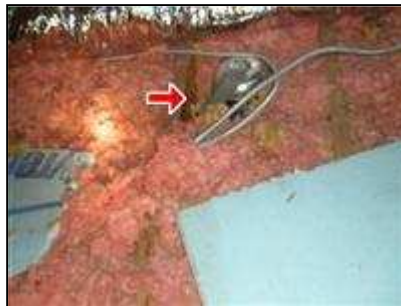
9.0 Picture 1 Insulation Voids

9.0 Picture 2 Insulation Voids

9.0 Picture 3 Insulation Voids

9.0 Picture 4 Insulation Voids

(1) There are several areas in attic above the kitchen and living rooms where the insulation is lifted or has voids around boxes and lights. This will cause significant loss of energy. I recommend further evaluation and repair by a qualified insulation contractor.

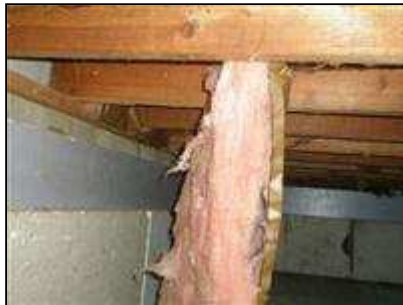
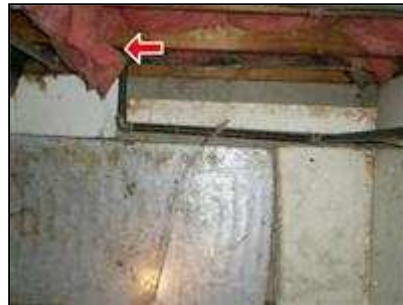
9.4 Picture 1 Falling Insulation

9.4 Picture 2 Loose Insulation

There is falling insulation in the crawlspace. If you decide to insulate the entire crawlspace, the vapor barrier or Kraft Paper needs to be installed toward the heated space.

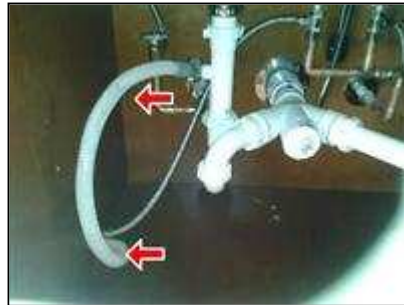
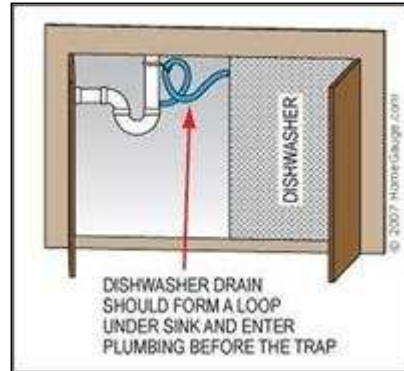
10.0 Picture 1 Discharge Hose

The dishwasher discharge hose does not loop above the bottom of the sink and drain into a trap. This may allow sewer gas to back up into the dishwasher line or allow backed up waste water from the sink to enter the dishwasher. I recommend further evaluation and repair by a licensed plumber. See article 4C.36 for additional information.

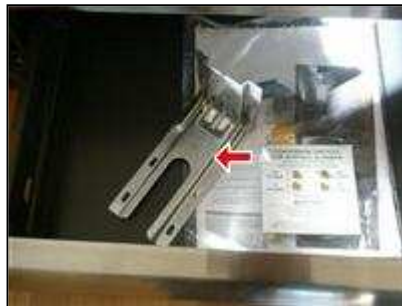
10.1 Picture 1 Anti-Tip Bracket
Not Installed

The kitchen range does not appear to be secured to the wall or floor with anti-tip bracket. This is a safety hazard because the range could tip over and cause burns or injury. The brackets have been shipped with all ranges since 2002. You should have the range secured to the wall according to manufacturer's recommendations.
